# Modification to undercarriage system

**Classification - Mandatory**

Applicability - All monowheel Europa aircraft

Mod no 37 3 November, 1996 Page 1 of 3

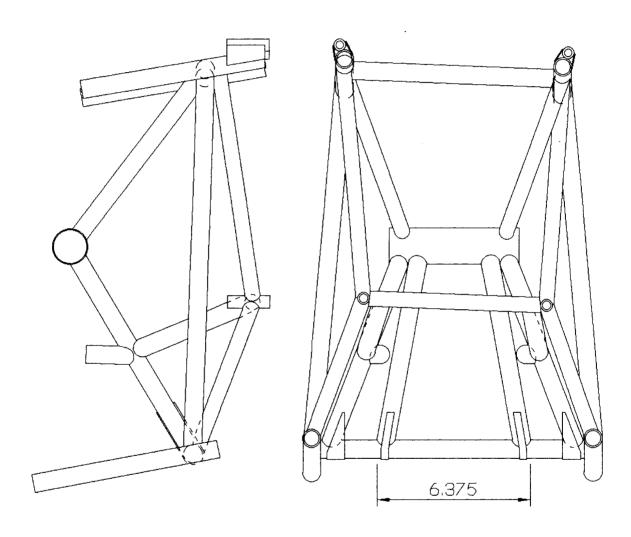
This modification provides reinforcement to the bottom horizontal tube (swinging arm pivot) of the undercarriage mounting frame. It also calls up minor modifications to the shock absorber assembly.

Fig 1. View showing positions for welding extra tubes.

- 6. Refer to figure 1, and remove the paint finish from the areas affected by the welding.
- 7. The bearing side location guides are tack welded to the bottom horizontal tubes. Fully weld those three edges which do not provide the bearing location. File the two supplied tubes to fit over these guides. The top of the tubes should be positioned to allow a full weld around them, and as close to the existing vertical support tubes as possible. Weld the tubes in place.

- 8. Weld the 4 reinforcing straps as shown. It may be easier to accomplish this by cutting each strap into two halves, forming them into "J" sections, and welding them separately, finishing off with a joining weld at the bottom of the tubes.

- 9. Restore the paint finish. Take especial care to apply a good paint coverage between the outer gusset plates. After the paint has fully dried apply a mastic material such as silicone between the gussets to prevent a water trap.
