## **Inspection of Europa Glider Wing Spars**

**Applicability:** All Europa Motor Glider wings

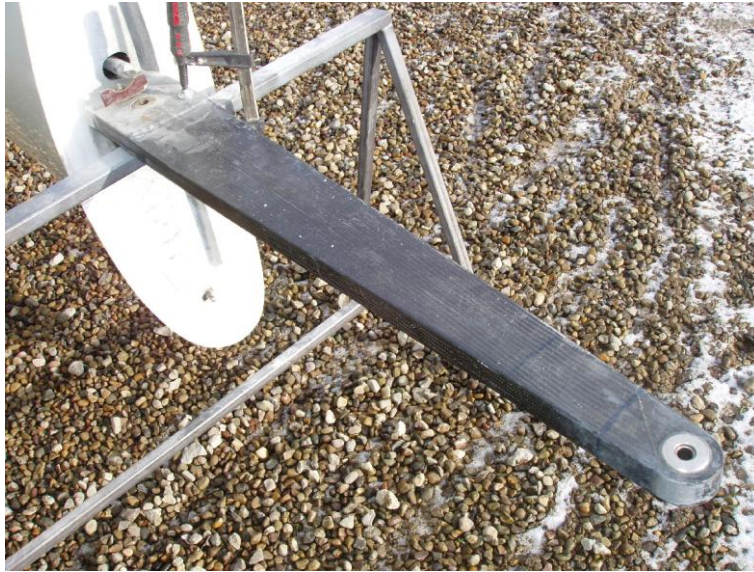
Inspect spar tang on all four surfaces

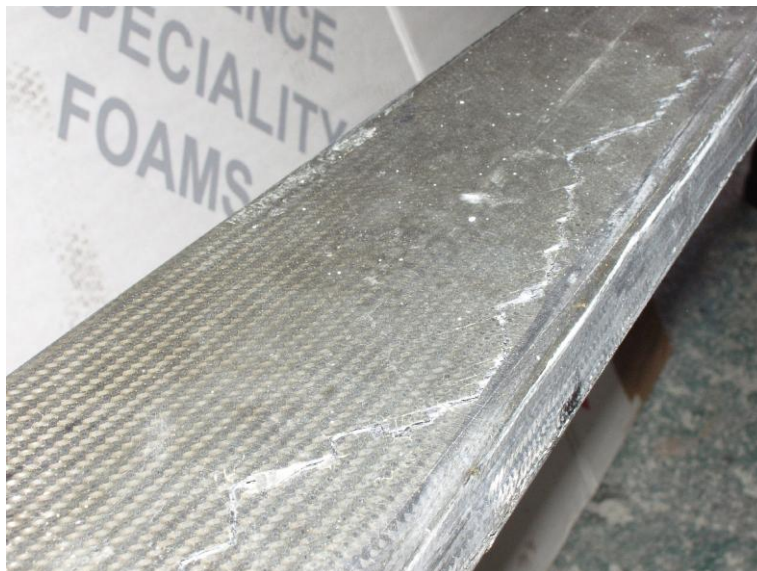
View of cracks that may be present in spar webs

2. If any cracks are found in the spar tang cloths the wings **are not to be flown** until Mod 78 has been incorporated.
3. If no cracks are found the glider wings can continue to fly for a further 25 hours subject to the following additional flight limitations;

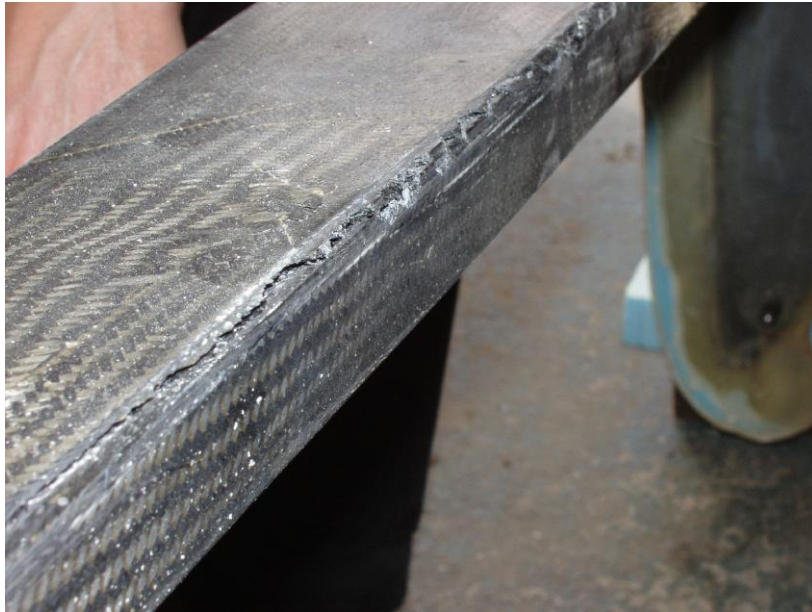
View of cracks that may be present at spar corners
