## **Inspection of Europa Glider Wing Spars**

**Classification:** Mandatory

**Applicability:** All Europa Motor Glider wings

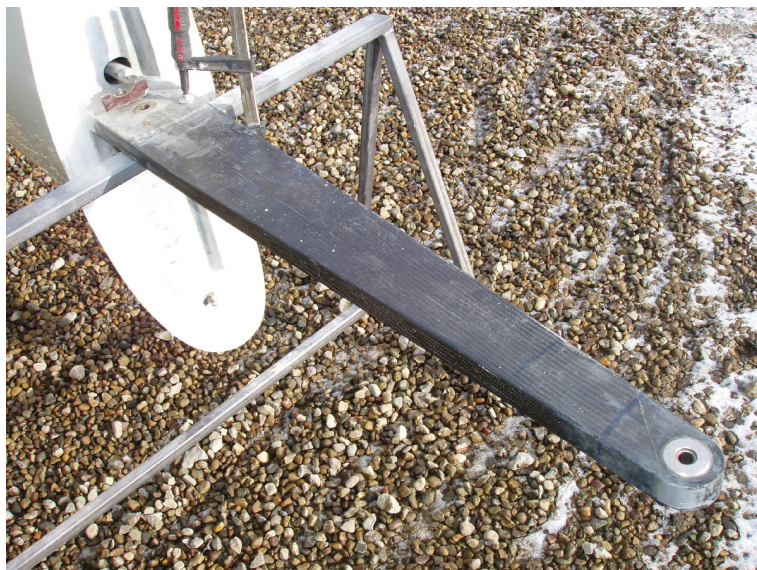
Inspect spar tang on all four surfaces

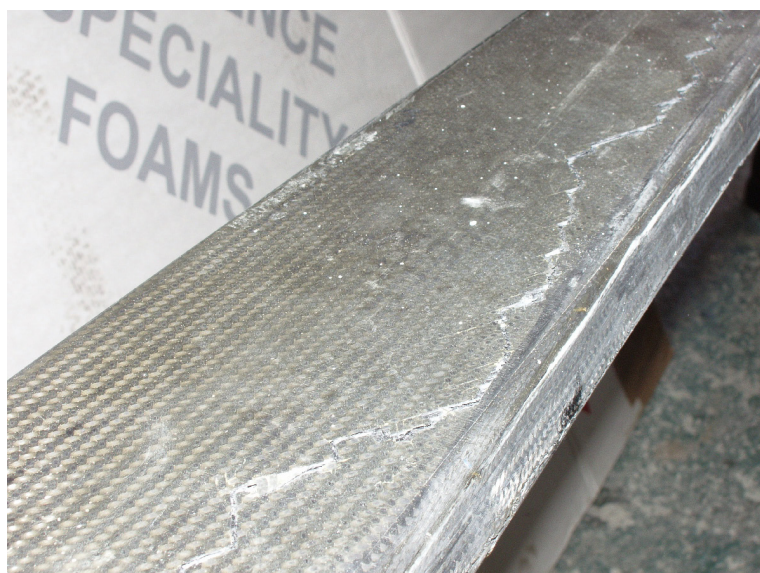
View of cracks that may be present in spar webs

2. If any cracks are found in the spar tang cloths the wings **are not to be flown** until Mod 78 has been incorporated.
3. If no cracks are found the glider wings can continue to fly for a further 25 hours subject to the following additional flight limitations;

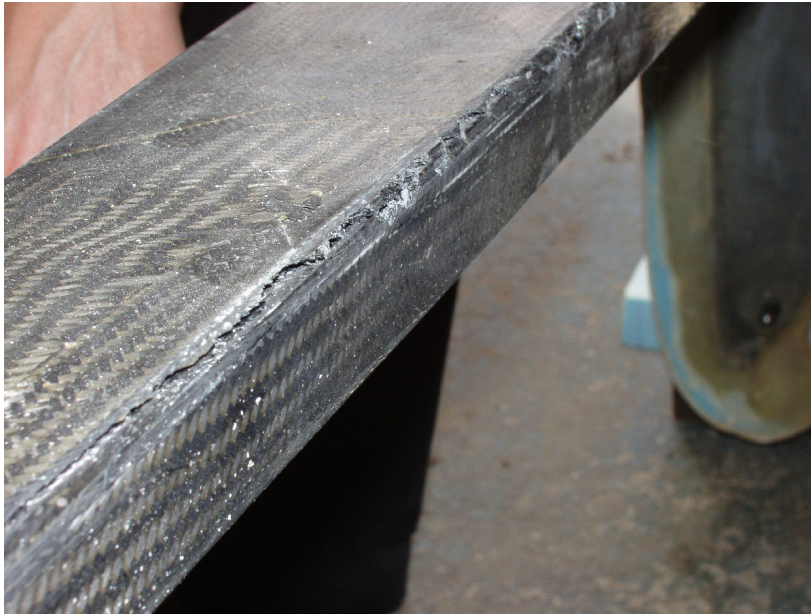
View of cracks that may be present at spar corners
